Manhole Inspection Summary

Manhole # S35UU_018MH

Insp Date: 1/11/07 11:54 AM

Location Address: **2900 GUILFORD AVE**

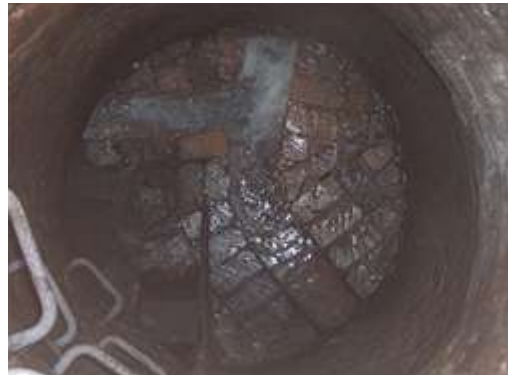
Top View

Barrel infiltration. Bench debris.

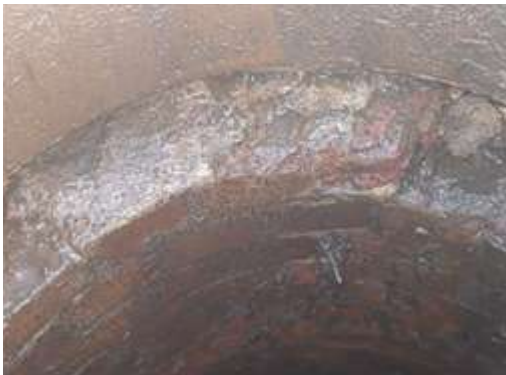
Defect

Frame leaks. Frame offset. Adjustment deterioration and infiltration. Corbel root intrusion.

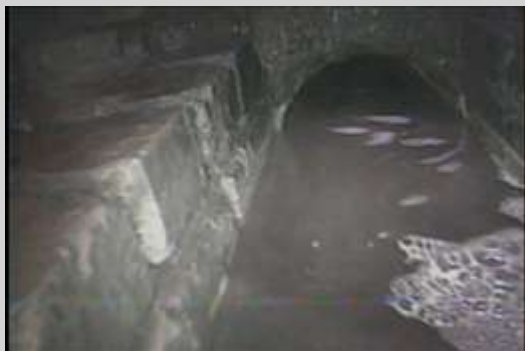
8 in. Circular Gravity Sewer Pipe In @ 5 O'Clock

Channel deterioration.

Infiltration: **Evidence** Pipe Seal Cond: **Unknown**
